CASE STUDY

Manalapan Seawall

Storm Protection/Erosion Control – Palm Beach, Florida

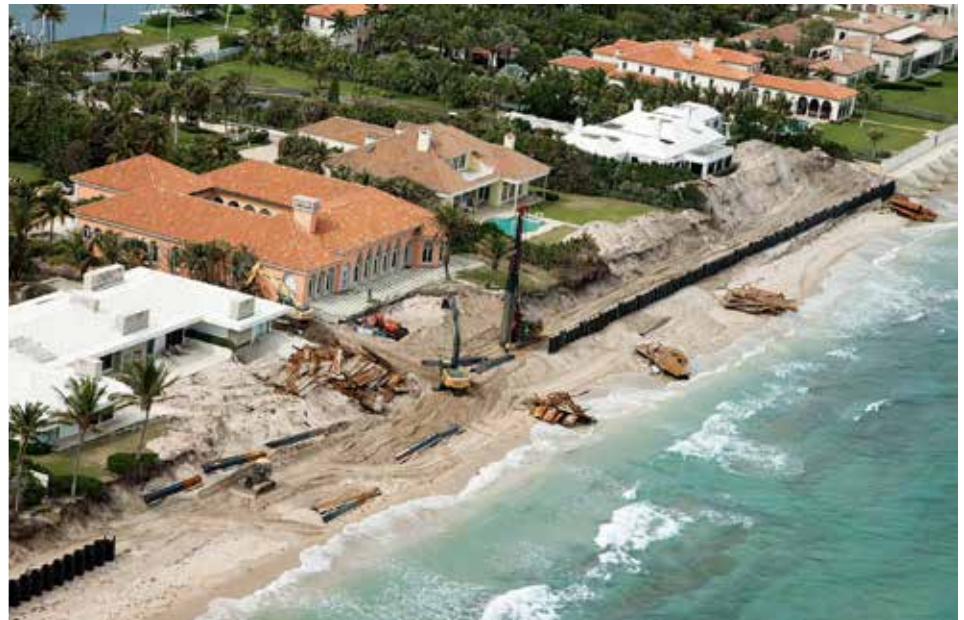
In Manalapan, the sea water over topped the sea walls, washed away the soil, exposed the concrete deadmen and the steel tieback anchors snapped. With its support system compromised, the steel sheet piles failed and fell toward the ocean. Sea water flooded the oceanfront properties and caused significant damage to the ultra prime real estate.

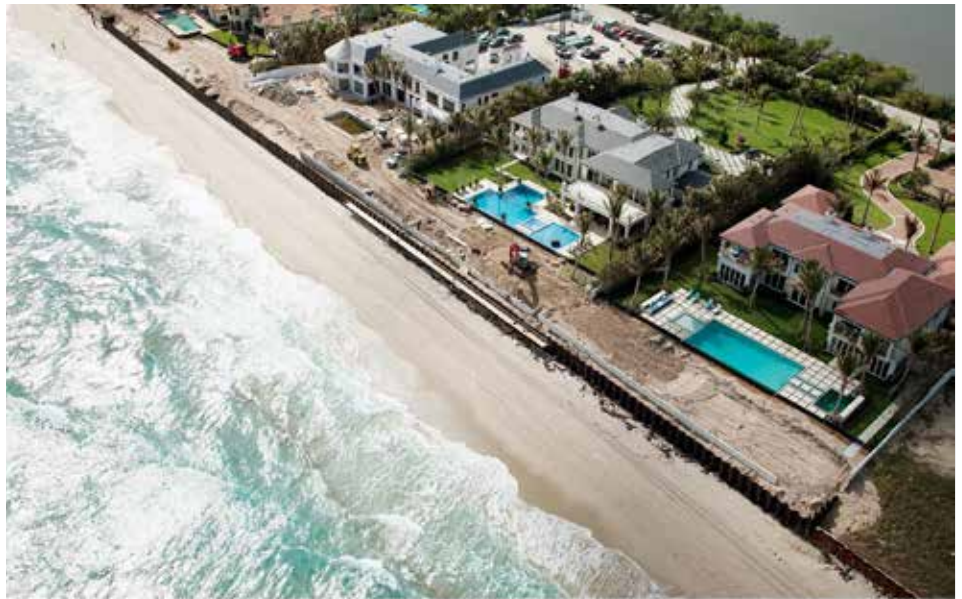
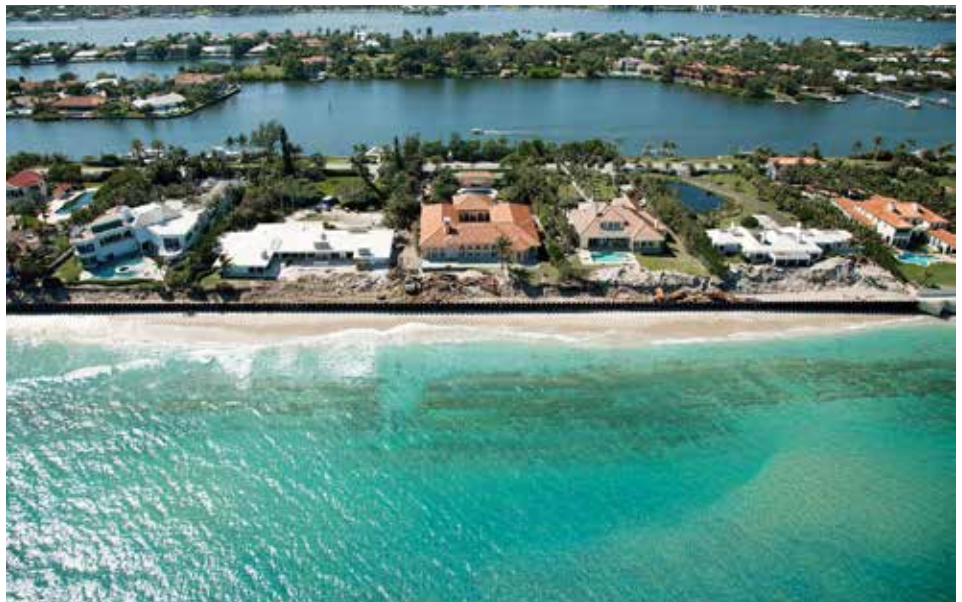
In a majority of the ocean-side properties, Skyline assisted with the design of a T-wall, with the main wall at a height of 8 feet above the mud line, an increase from the previous height of 5 feet. To stabilize the sea wall, shorter steel sheets were driven into the limestone at 28' to 30' depth. The anchor walls were connected to the main wall using

C9 connectors. The C9s were welded to the AZ26-700 sheets to provide the 90 degree T-wall connection.

As the stabilizing sheets got further inland, shorter lengths of sheet pile were needed. Skyline cut considerable time off its supply timeline by using drops from longer sheets.
