CASE STUDY

Port Jefferson

Long Island, New York

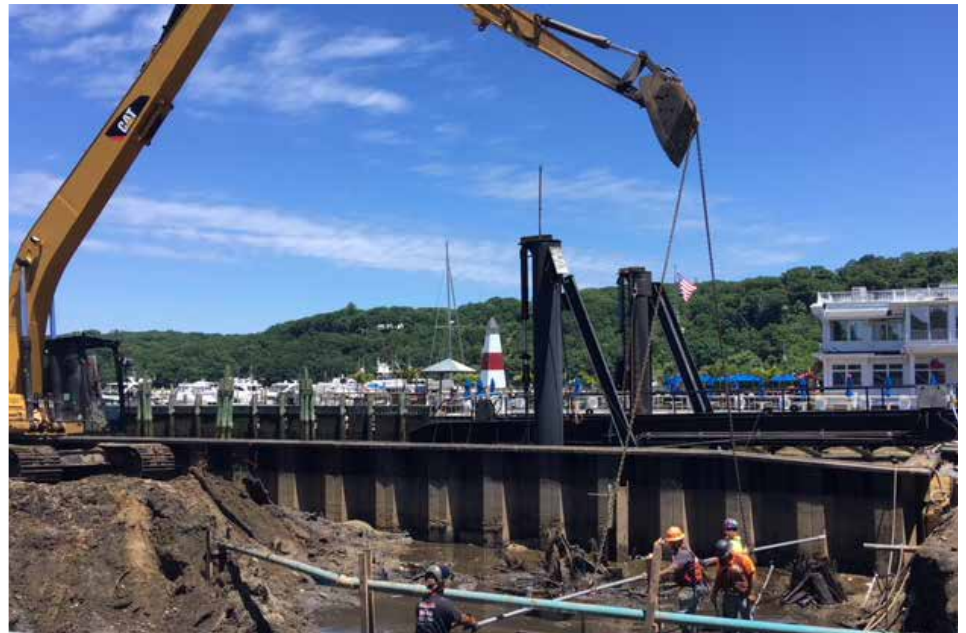
The seven-foot tide change gave workers a small window to install the tie rods. The threaded bar and walers were used in combination to tie the bulkhead wall to the deadman wall. Installation could only be accomplished at the mid-point in the tidal range during daylight hours.
