CASE STUDY

Port Jefferson

Long Island, New York

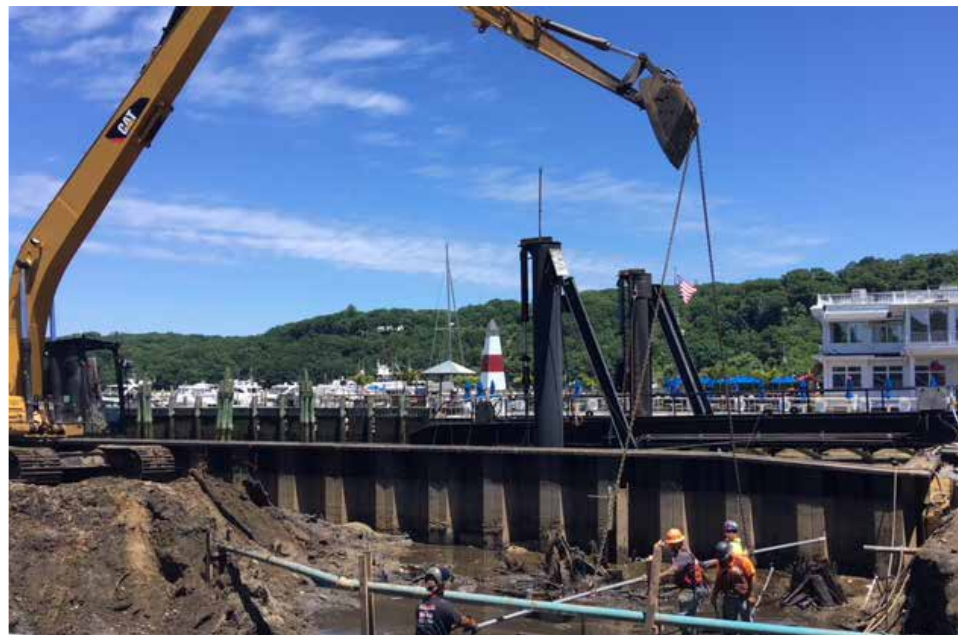
The seven-foot tide change gave workers a small window to install the tie rods. The threaded bar and walers were used in combination to tie the bulkhead wall to the deadman wall. Installation could only be accomplished at the mid-point in the tidal range during daylight hours.

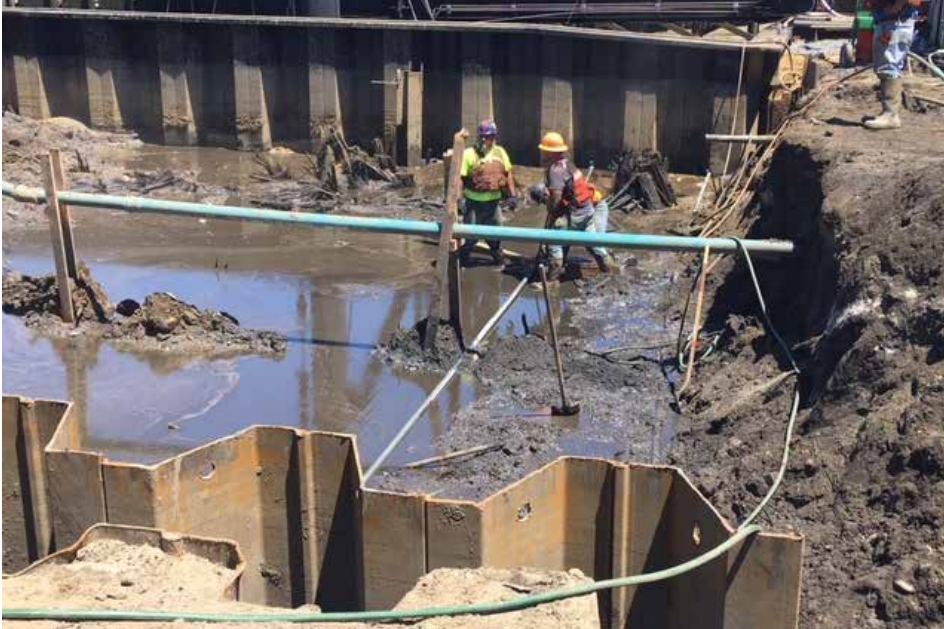
In order to extract the old sheet piling from around the pier, Chesterfield Associates used an ICE Model 416 hydraulic vibratory driver/extractor that was mounted on a crawler crane. In several places, the old sheet piling was left in place due to the extent of corrosion and the difficulty to remove them. All of the new piling was driven in place using a more powerful ICE Model 50B vibratory hammer which had the size and energy to drive up to 90 feet in the soil conditions at the pier.
