Portsmouth Seawall

Portsmouth, Virginia

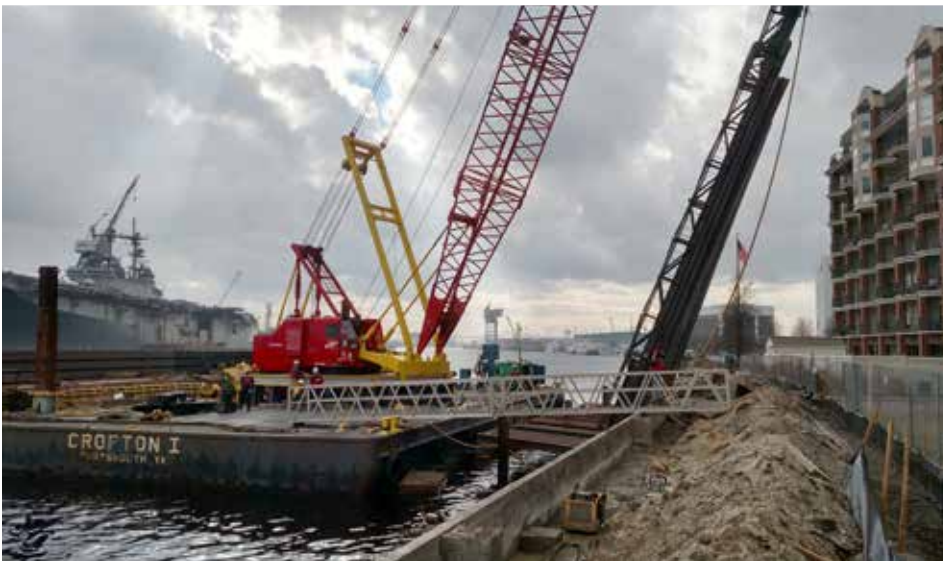
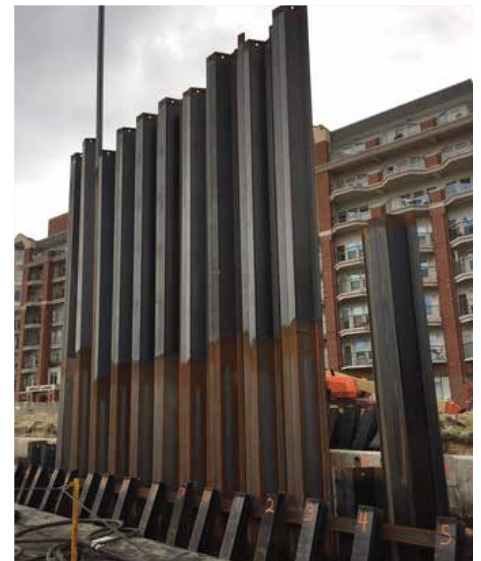
Industries. Crofton performed an additional underwater inspection of the failed section of the seawall and found the reaction piles had failed and, as a result, the seawall had deflected and caused the double T deck panels for the elevated walkway to become unsafe for the public.

Crofton looked to Skyline Steel for their engineering help and sheet pile expertise. Skyline Steel provided engineering drawings for the redesign of the seawall. A crane was brought in on a barge to the project site where the existing deck sections were removed. After demolishing damaged concrete bent piles and reaction piles, new AZ-38 700N steel sheet piles were driven to design depth approximately two feet from the existing seawall to allow for room to work. Once the sheet pile was in place, a concrete cap was poured and new steel H-pile reaction beams and concrete pile bents were

installed to support the concrete deck sections.
