Manalapan Seawall

Storm Protection/Erosion Control – Palm Beach, Florida

CASE STUDY

Manalapan Sea Wall

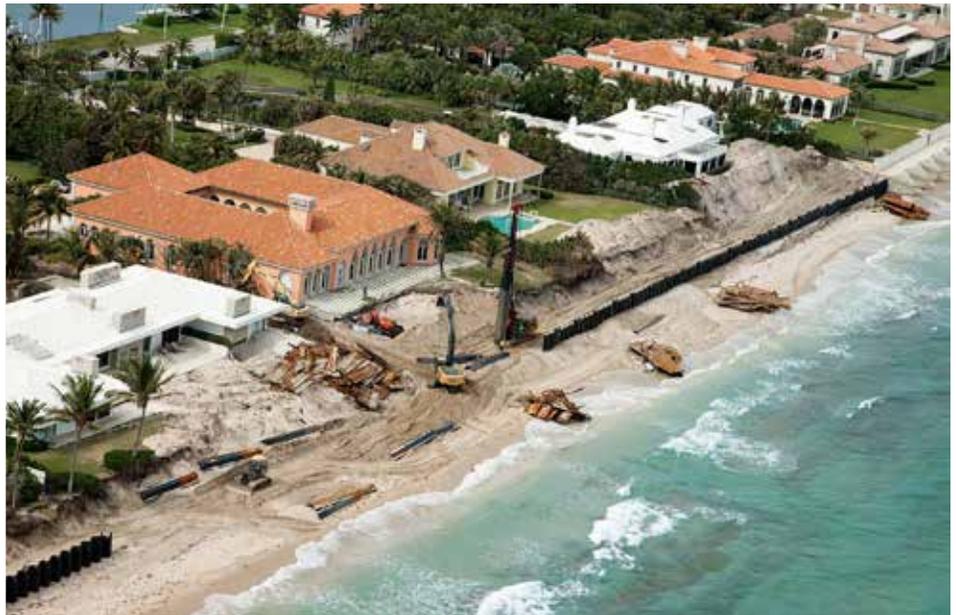
In Manalapan, the sea water over topped the sea walls, washed away the soil, exposed the concrete deadmen and the steel tieback anchors snapped. With its support system compromised, the steel sheet piles failed and fell toward the ocean. Sea water flooded the oceanfront properties and caused significant damage to the ultra prime real estate.

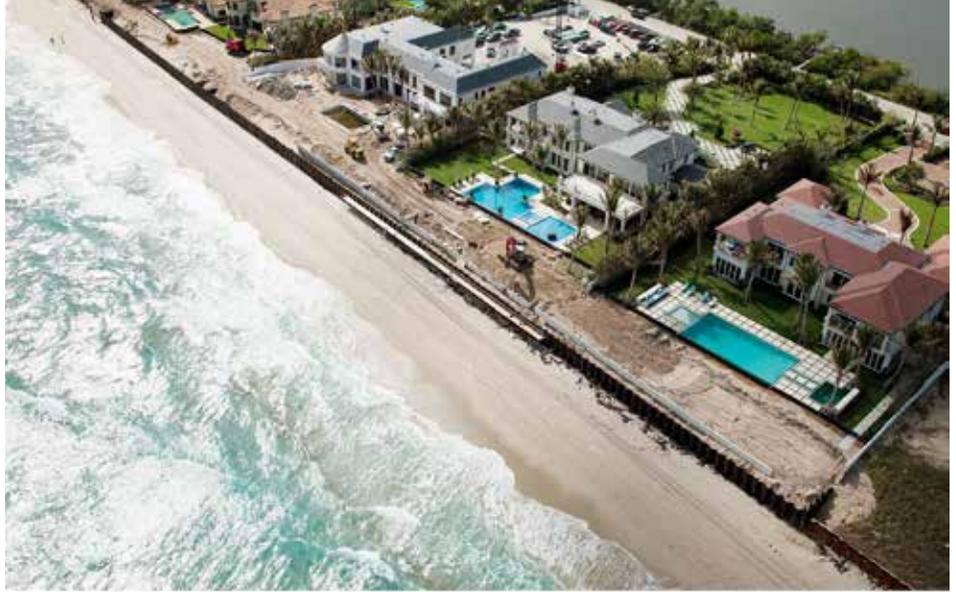
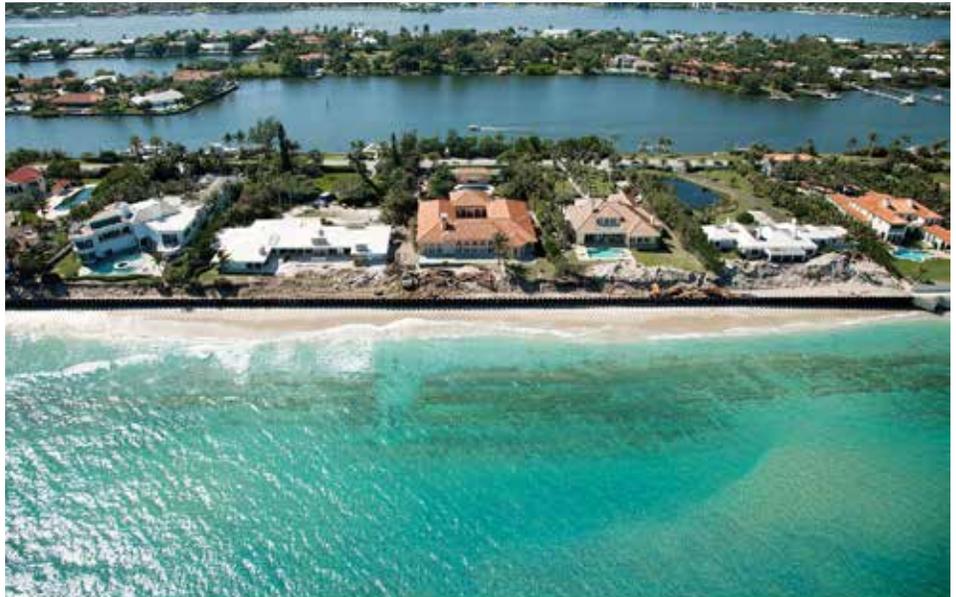
In a majority of the ocean-side properties, Skyline assisted with the design of a T-wall, with the main wall at a height of 8 feet above the mud line, an increase from the previous height of 5 feet. To stabilize the sea wall, shorter steel sheets were driven into the limestone at 28' to 30' depth. The anchor walls were connected to the main wall using C9

connectors. The C9s were welded to the sheets to provide the 90 degree T-wall connection.

As the stabilizing sheets got further inland, shorter lengths of sheet pile were needed. Skyline cut considerable time off its supply timeline by using drops from longer sheets.
